PRACTICAL COMPLETION REPORT

Property Address:
Sample Street
SAMPLE REPORT QLD 0000

Date of Inspection:
8th July 2014

Report Reference:
14324
HEAD OFFICE
PO Box 355 HELENSVALE QLD 4212
Phone: 1300 467 739

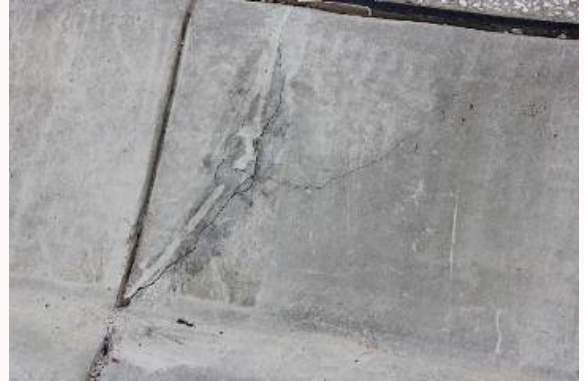
Front section of property.

Visible cracking to driveway. Average size of cracking appears to be <1mm.

Driveway may be part of the Body Corporate (Strata Title). Further advice should be gained from the Body Corporate in relation to any defects with the property as the purchaser may be liable for defects or faults in the common property.

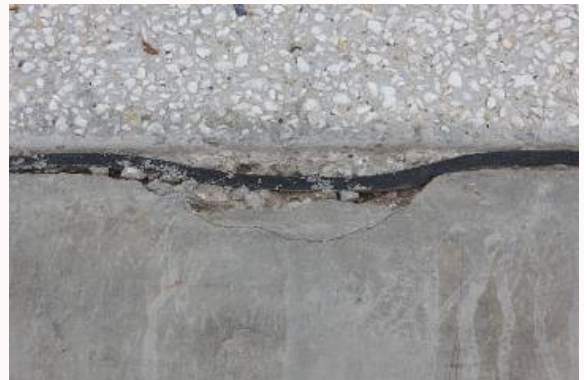
Front section of property.

Minor spalling to driveway.

Driveway may be part of the Body Corporate (Strata Title). Further advice should be gained from the Body Corporate in relation to any defects with the property as the purchaser may be liable for defects or faults in the common property.

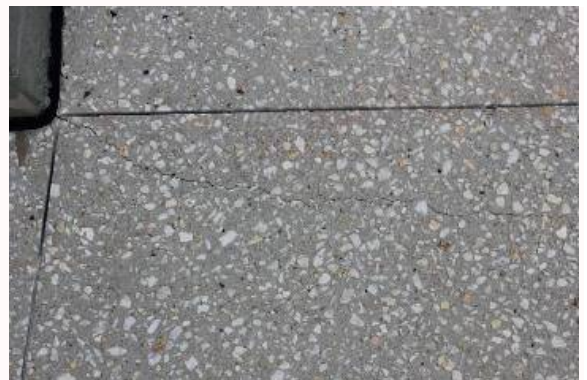
Left side of property.

Pathway constructed from concrete.
Visible cracking to pathway. Average size of cracking appears to be <1mm.

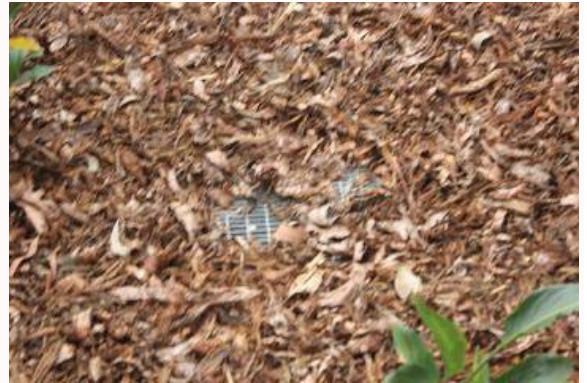
Drain grate covered with bark.

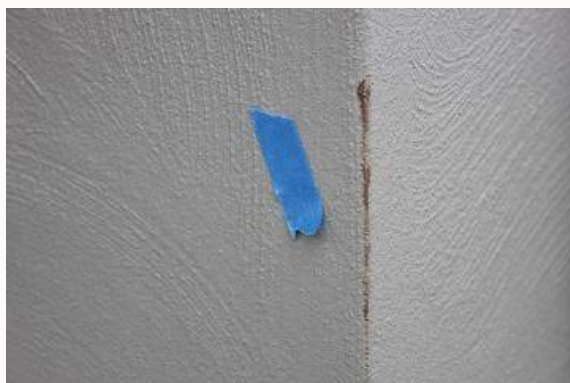
Rear section of property.

External walls are brick veneer rendered.
Damage to paint work of wall.

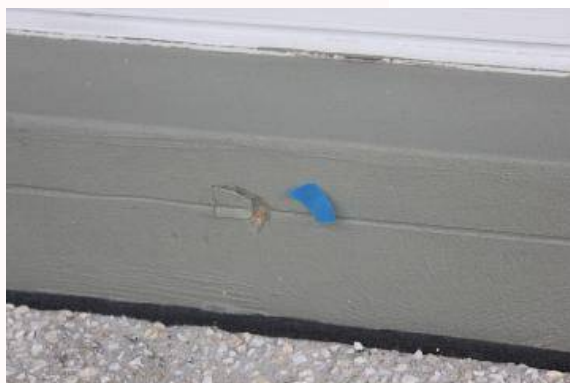
Rear section of property.

External walls are brick veneer rendered.
Damage to wall under sliding door.

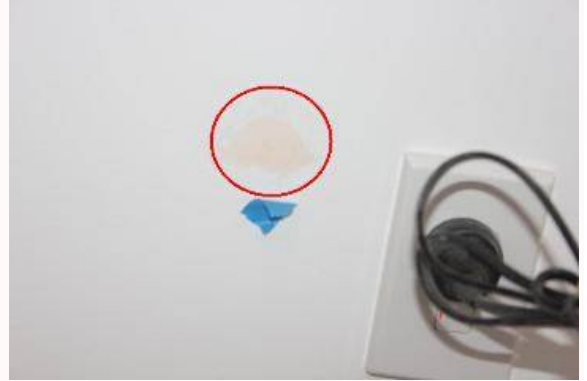
Unpainted patch to ceiling.

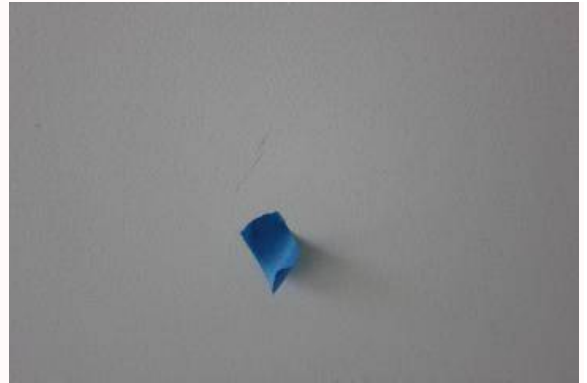
Walls constructed from plasterboard.
Mark to wall as indicated by blue tape.

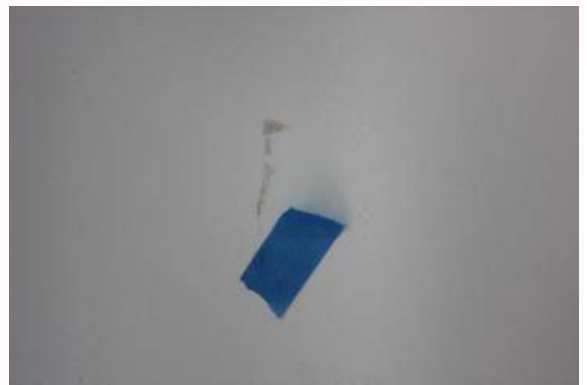
Mark to wall as indicated by blue tape.

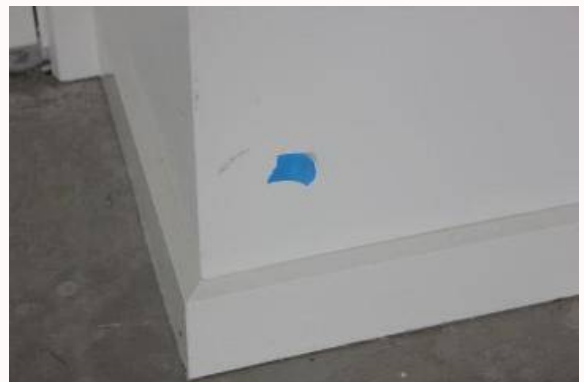
Mark to wall as indicated by blue tape.

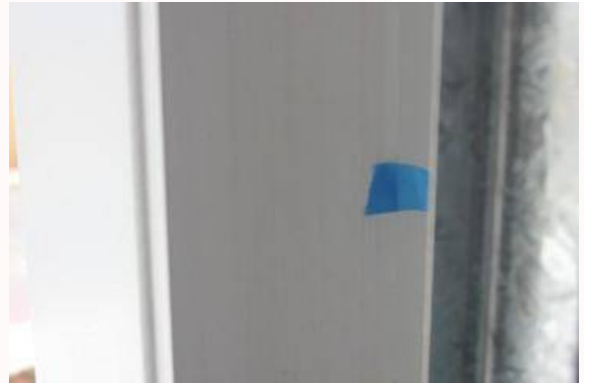
Door frame and architrave to garage door constructed from timber.
Finish coat required to architrave.

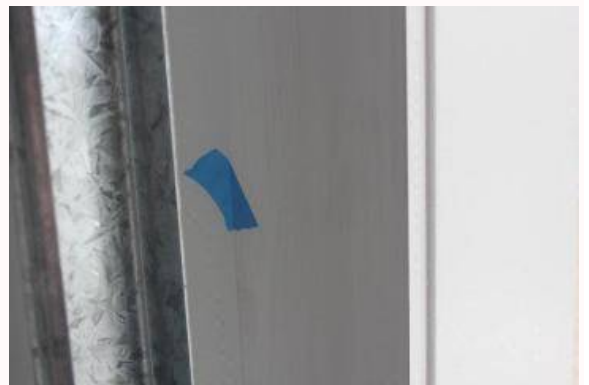
Finish coat required to architrave.

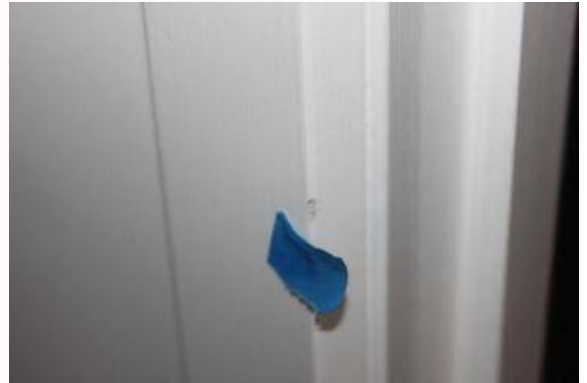
Door frame and architrave constructed from timber.
Impact mark on door frame as indicated by blue tape.

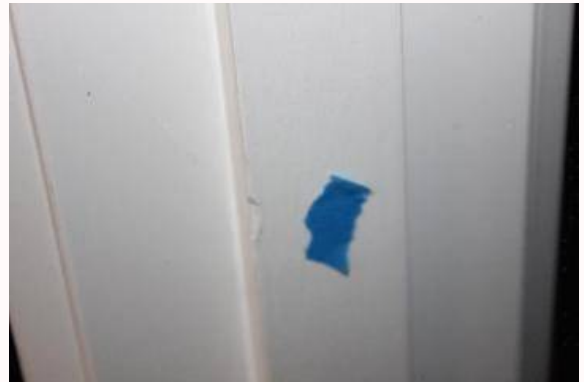
Impact mark on door frame as indicated by blue tape.

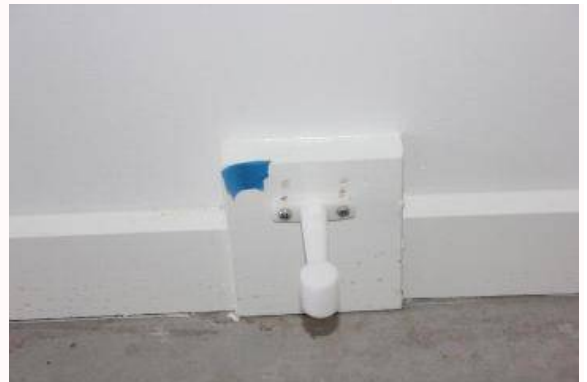
Skirting material is timber.
Painting required to door stop.

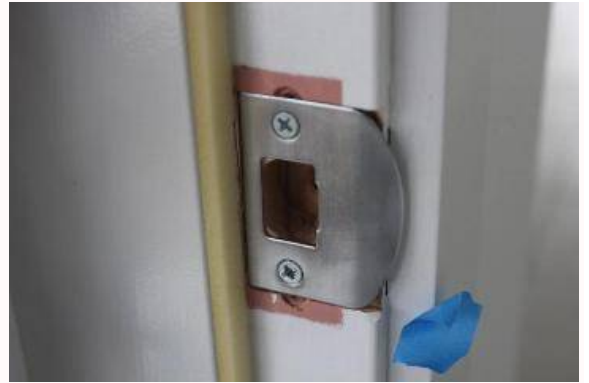
Poor finish and installation to keeper plate.

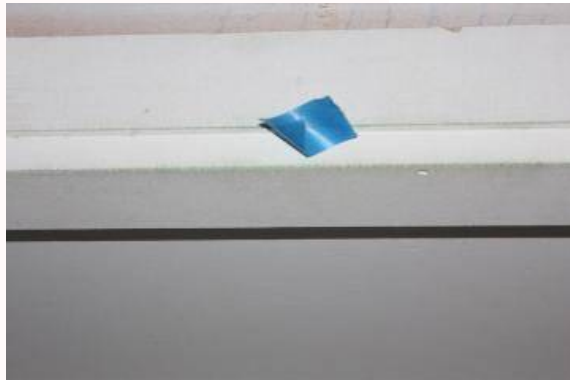
Ceiling material is plasterboard sheets.
Unpainted manhole frame and architrave.

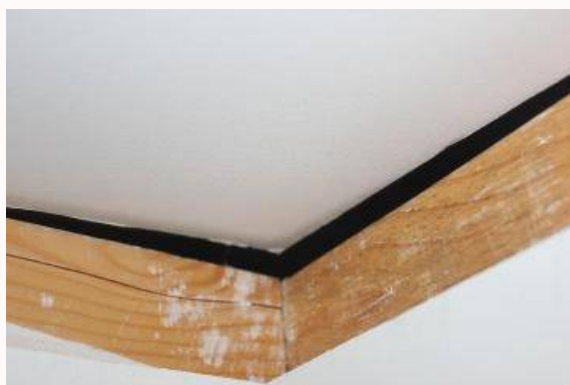
Manhole cover not fitting correctly in frame.

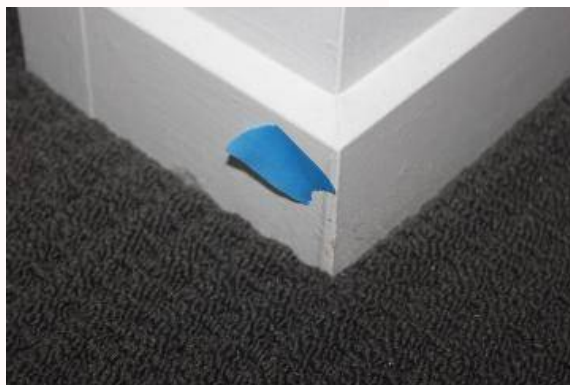
Skirting material is timber.
Unpainted skirting board.

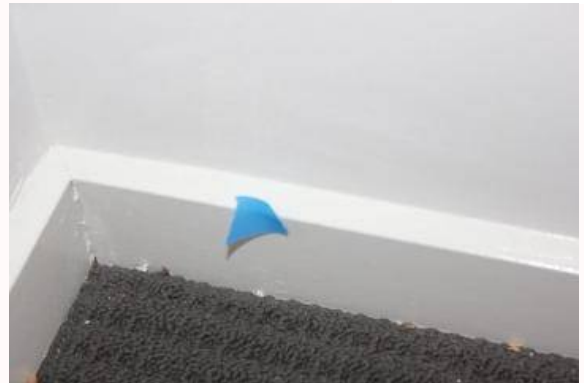
Skirting material is timber.
Mark on skirting as indicated by blue tape

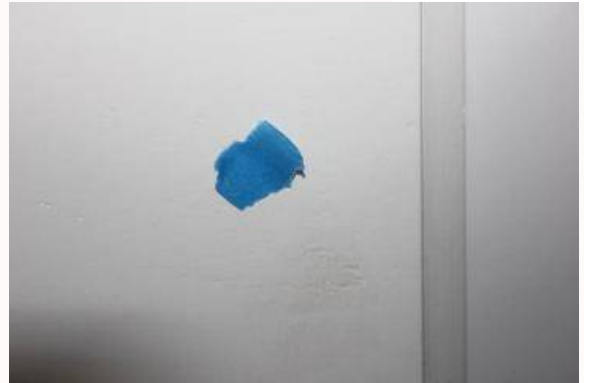
Mark on wall as indicated by blue tape

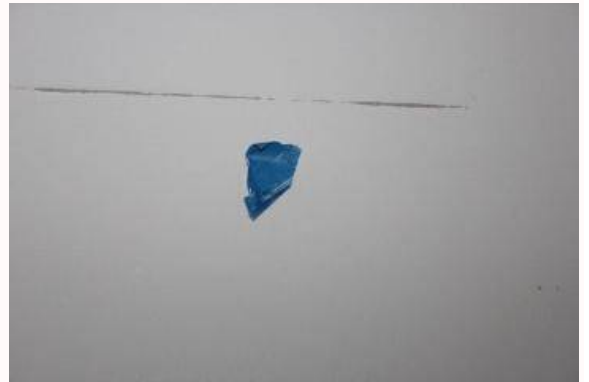
Mark on wall as indicated by blue tape.

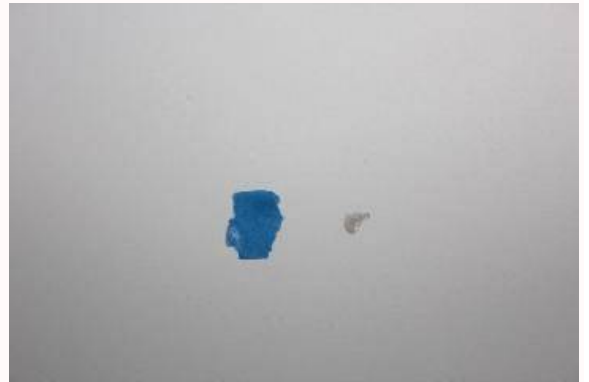
Mark on wall as indicated by blue tape.

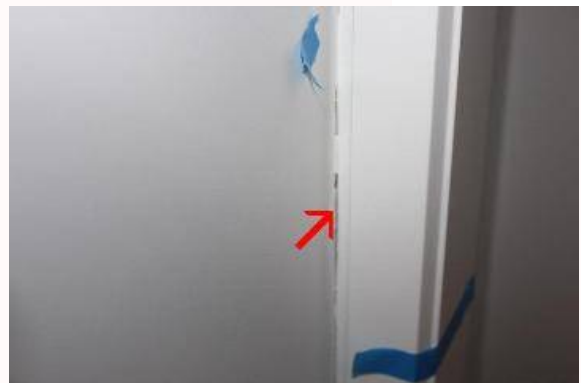
Walls constructed from plasterboard.
Poor finish to internal corner at both sides of wall
adjacent to wardrobe frame.

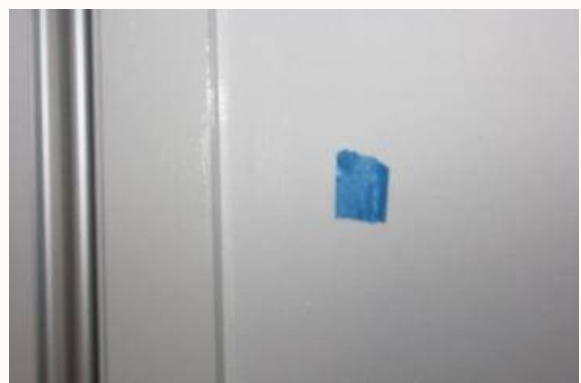
Gloss paint on wall.

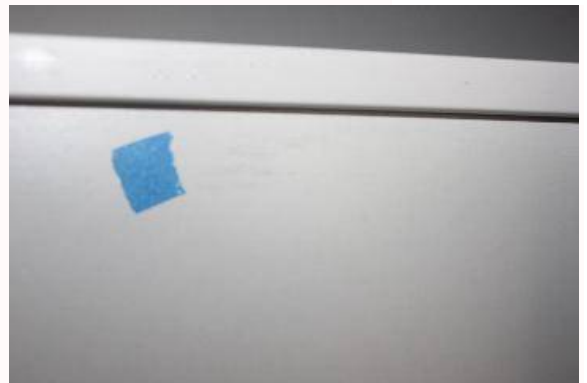
Condition of the built-in wardrobes is generally good.
Marks on shelf support.

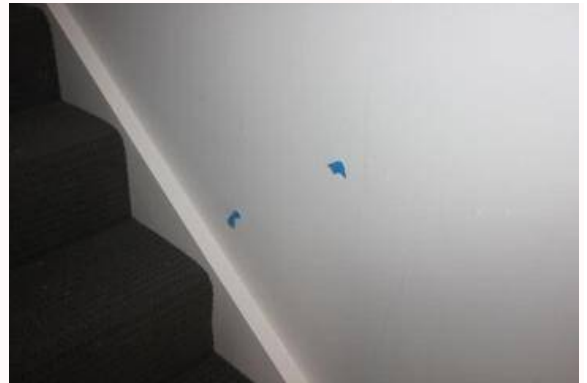
Walls constructed from plasterboard.
Marks to wall as indicated by blue tape.

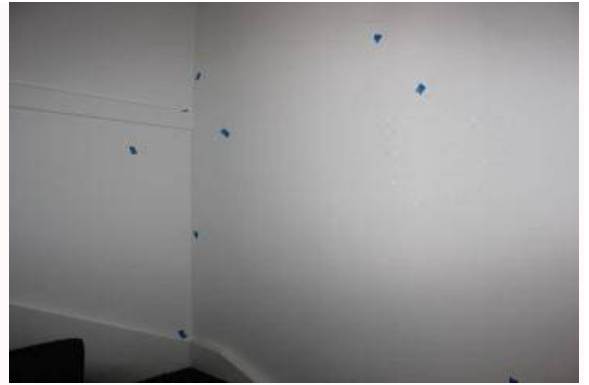
Marks to wall as indicated by blue tape.

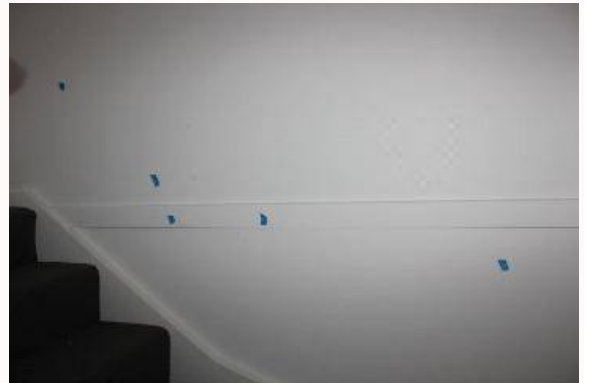
Marks to wall as indicated by blue tape.

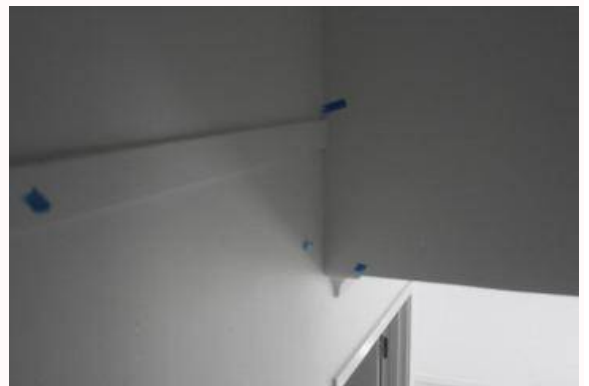
Marks to wall as indicated by blue tape.

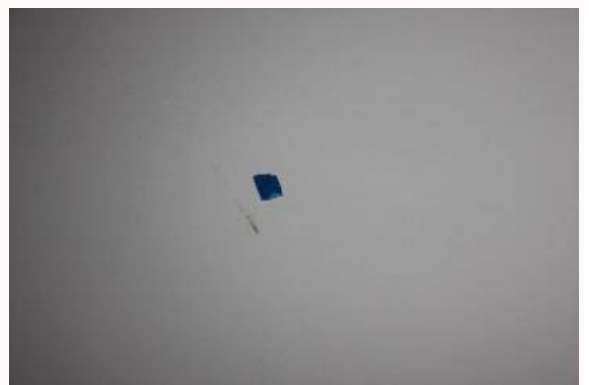
Mark to wall as indicated by blue tape.

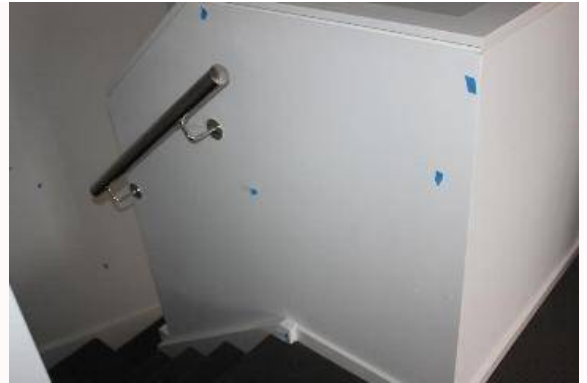
Marks to wall as indicated by blue tape.

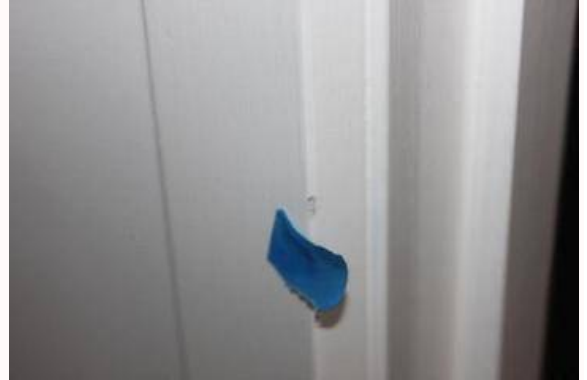
Paint over spray on cupboards.

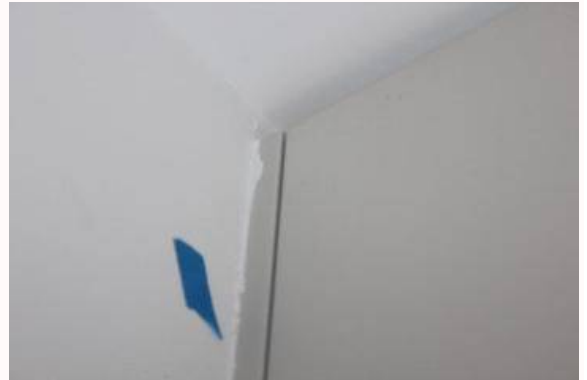
Paint over spray on cupboards.

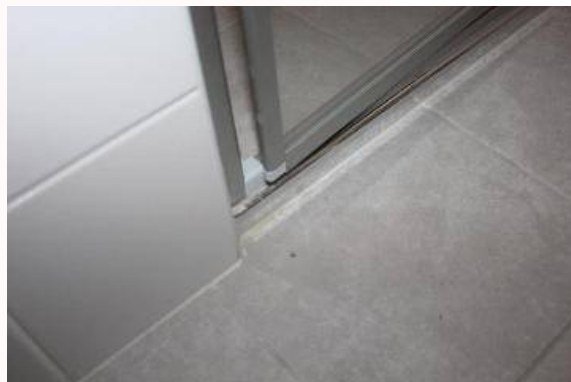
Overall condition of shower is generally good.
Shower screen doors require adjustment.

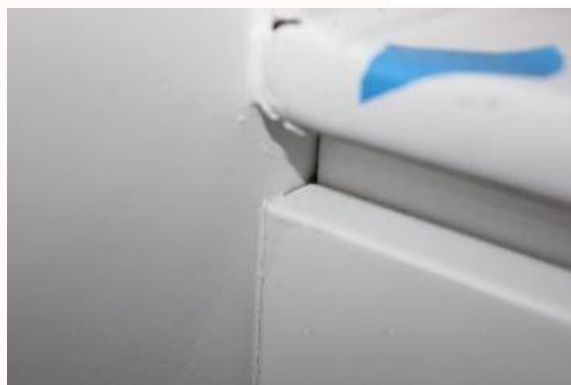
Condition of vanity unit is generally good.
Gap filling required at edge of tile and vanity to wall.

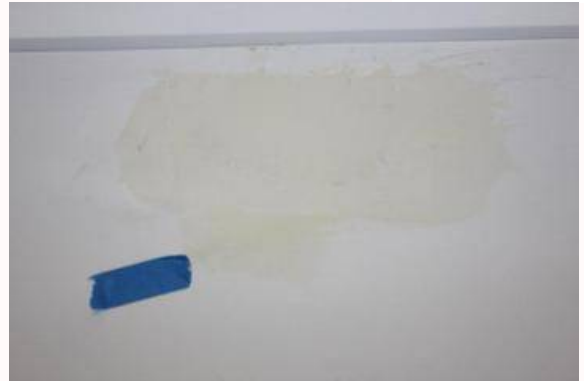
Walls constructed from plasterboard.
Painting required to patch repair.

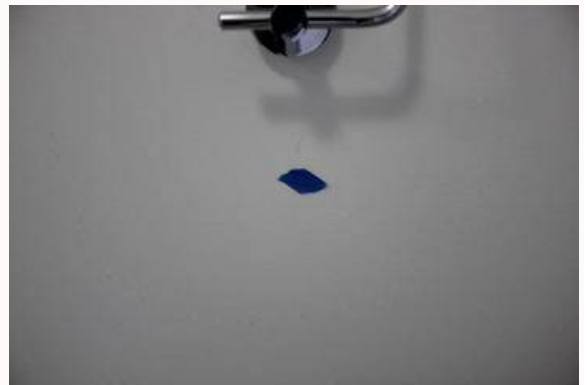
Walls constructed from plasterboard.
Mark on wall as indicated by blue tape.

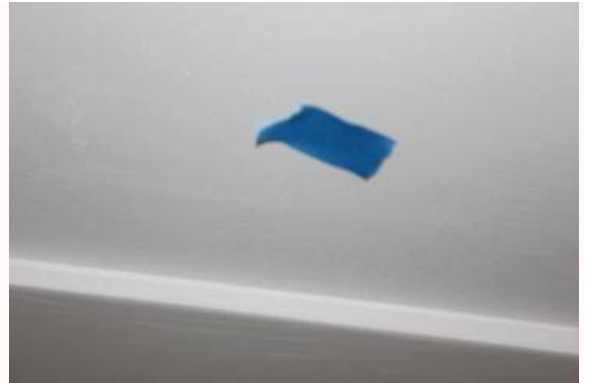
Walls constructed from plasterboard.
Mark on wall as indicated by blue tape.

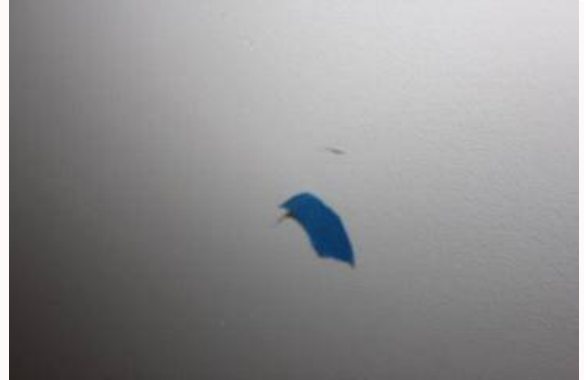
Walls constructed from plasterboard.
Mark on wall as indicated by blue tape.

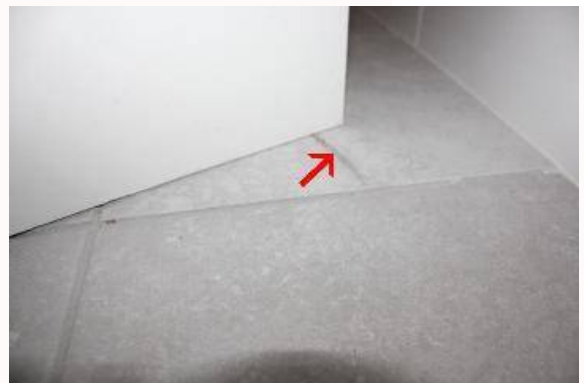
Floor is tiled.
Tile marked from door scraping on floor.

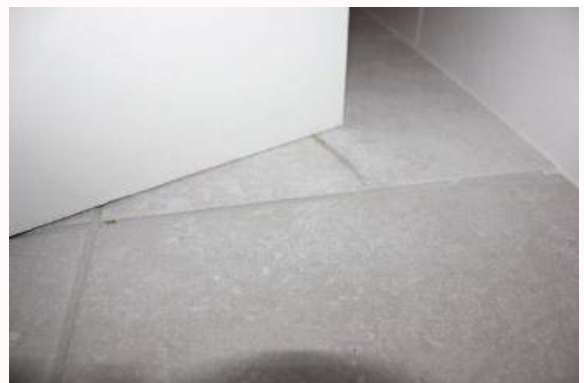
Door is timber.
Door binding on floor.
