PRACTICAL COMPLETION REPORT

Property Address:
Sample Street
SAMPLE REPORT QLD 0000

Date of Inspection:
8th July 2014

Report Reference:
14324
HEAD OFFICE
PO Box 355 HELENSVALE QLD 4212
Phone: 1300 467 739

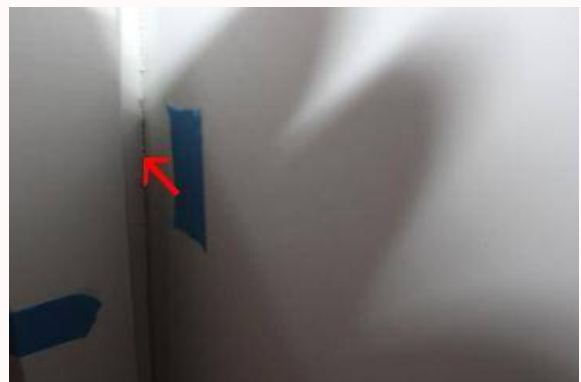
Poor finish to internal corner at both sides of wall
adjacent to wardrobe frame.

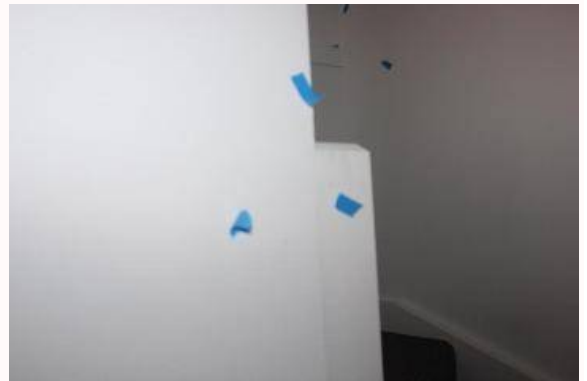
Marks to wall as indicated by blue tape.

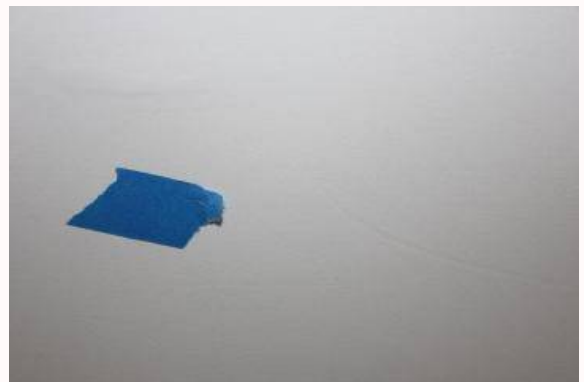
Walls constructed from plasterboard.
Mark on wall as indicated by blue tape.

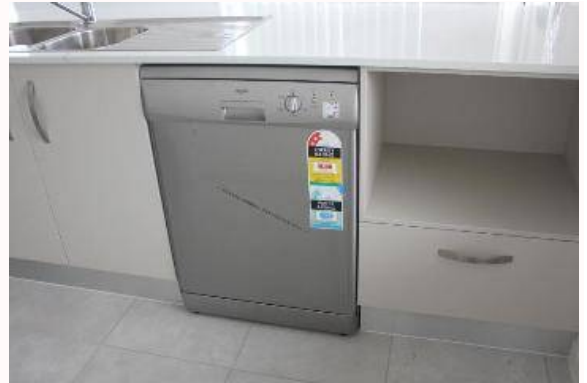
Dishwasher appears to be in a satisfactory condition.

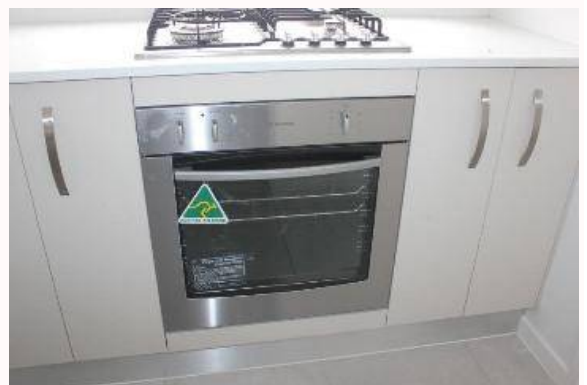
Oven appears to be in a satisfactory condition.

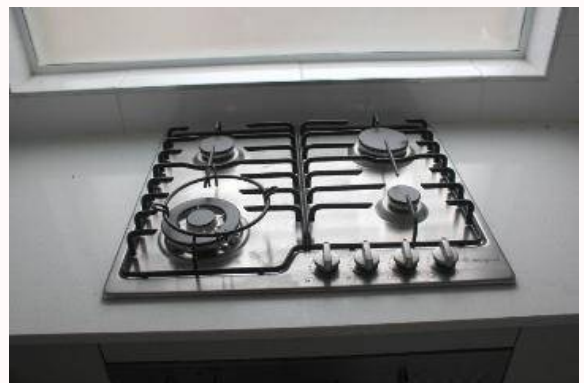
Hot plate appears to be in a satisfactory condition.

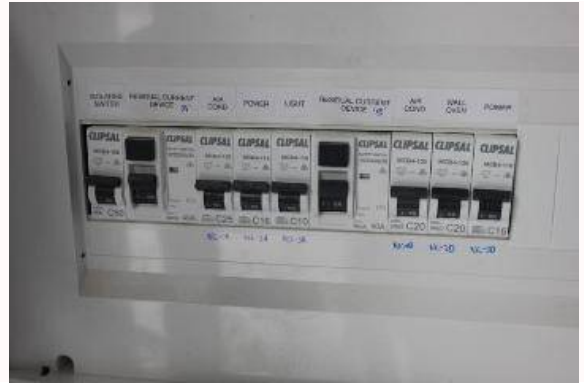
A residual current device (RCD) noted in the electric meter box. It is recommended that a licensed electrician is consulted to determine if all the power outlets are connected to this circuit and that it works.

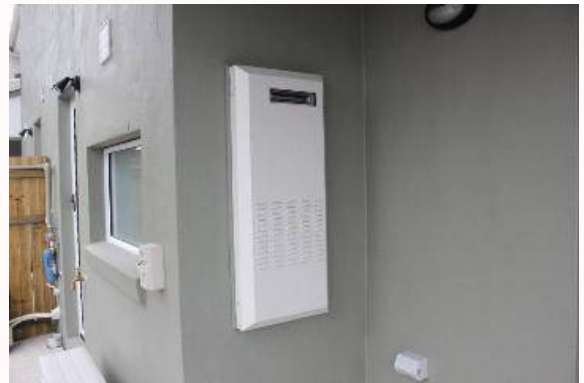
Instantaneous gas hot water system. Hot water system appears to be in working condition. No specific tests other than running the hot water from a tap was carried out. No determination has been made as to the suitability or adequacy of the hot water system in relation to capacity or otherwise.

We give no comment or opinion on the condition of the hot water system. It is recommended that a licensed plumber or suitability qualified person is contacted to obtain further advice on the hot water system.
